# ROAD SAFETY AUDIT: 2200 WEST IN LAYTON (GORDON AVE TO ANTELOPE DR)

8/24/2026

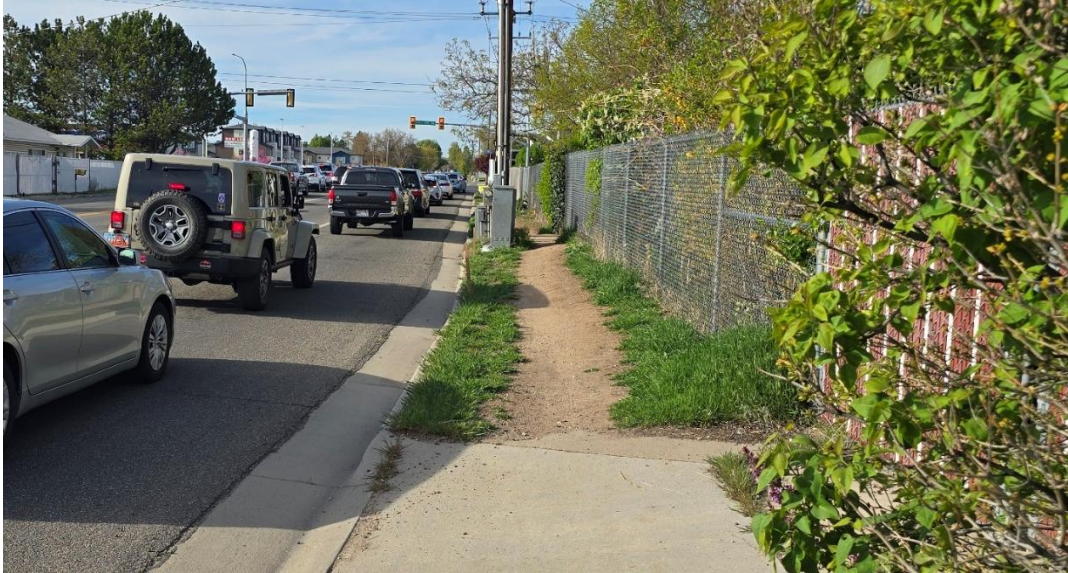
**Issue #1:** Large segments of sidewalk are missing north of the rail crossing.

- Complete missing sections of sidewalk

| ID | Location | Measure | CMF | 20-Year Benefit | 20-Year Cost | Benefit-Cost Ratio (B/C) |
|---|---|---|---|---|---|---|
| M-3 | Corridor Wide | Complete missing sections of sidewalk | 0.974 | \$3,202,000 | \$92,000 | 34.80 |

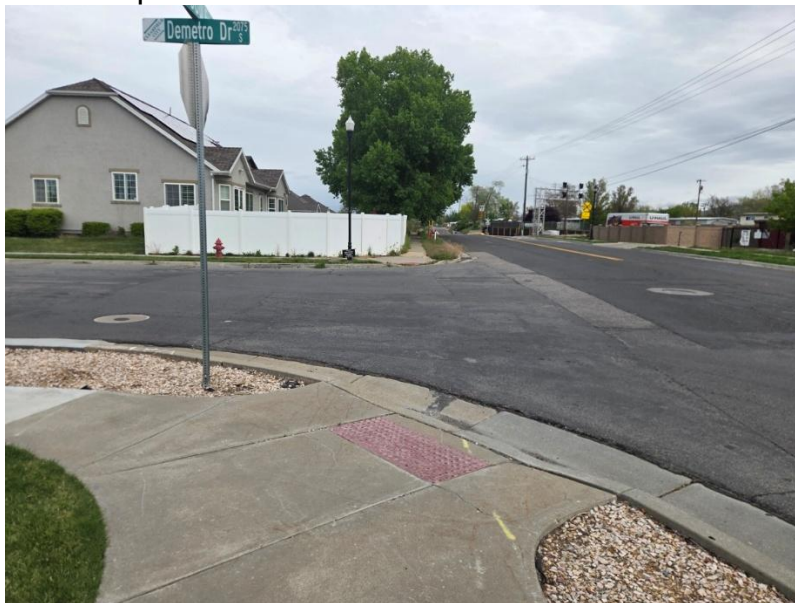
**Issue #3:** Pedestrian ramps are non-directional and do not meet current ADA standards.

- Update pedestrian ramps to meet ADA requirements

| ID | Location | Measure | CMF | 20-Year Benefit | 20-Year Cost | Benefit-Cost Ratio (B/C) |
|---|---|---|---|---|---|---|
| M-1 | Corridor Wide | Update pedestrian ramps to meet ADA requirements | 0.990 | \$1,231,000 | \$165,000 | 7.46 |

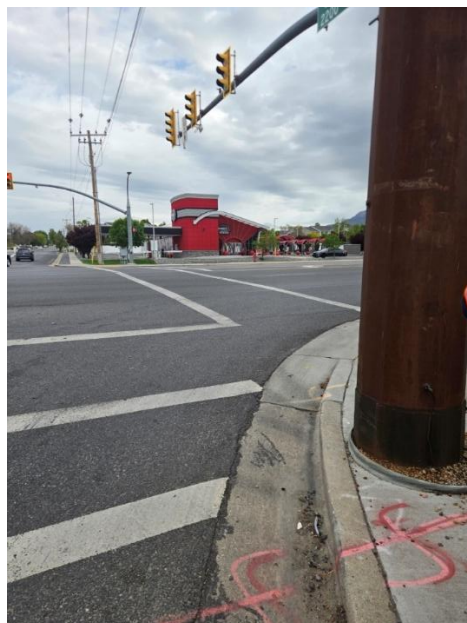
**Issue #2:** Pole and sound wall on southeast corner may restrict visibility of pedestrians for northbound drivers.

- Implement Leading Pedestrian Intervals
- Prohibit right-turn on red during pedestrian phase, particularly for the northbound and southbound

- Relocate pole and sound wall on southeast corner

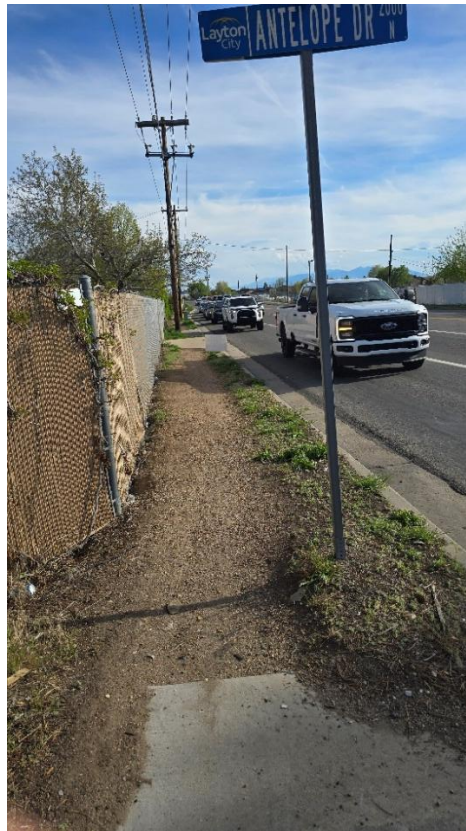
**Issue #8:** There are no sidewalks on the south leg, but pedestrian activity is evidenced by worn footpaths on both sides of the road.

- Install sidewalks on both sides of south leg

| ID | Location | Measure | CMF | 20-Year Benefit | 20-Year Cost | Benefit-Cost Ratio (B/C) |
|---|---|---|---|---|---|---|
| M-7 | Antelope Drive | Install sidewalks on both sides of south leg | 0.974 | \$642,000 | \$42,000 | 15.29 |

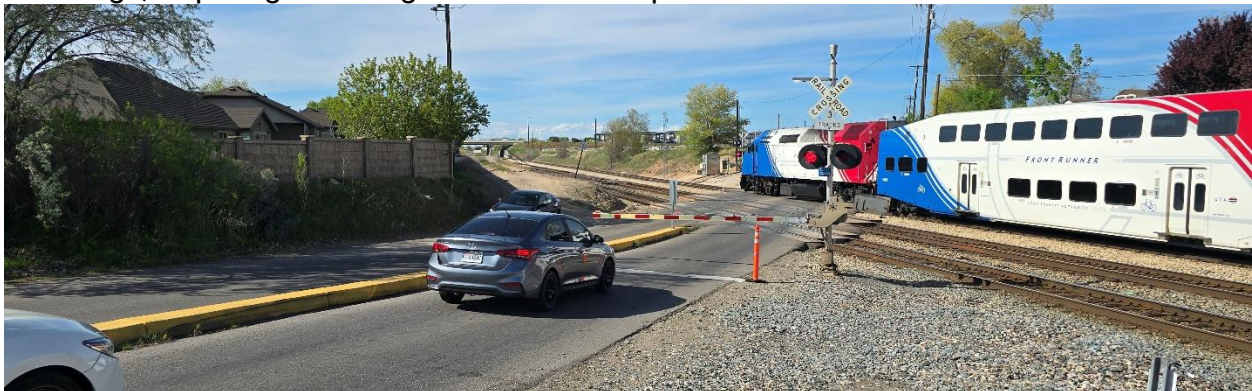
**Issue #1:** There are 80+ train crossings per day (freight and commuter rail) that create frequent interruptions to traffic flow. Future double tracking of commuter rail line will result in increased crossing events. Emergency response is impacted by railroad crossings, requiring rerouting when trains are present.

- Full roadway grade separation

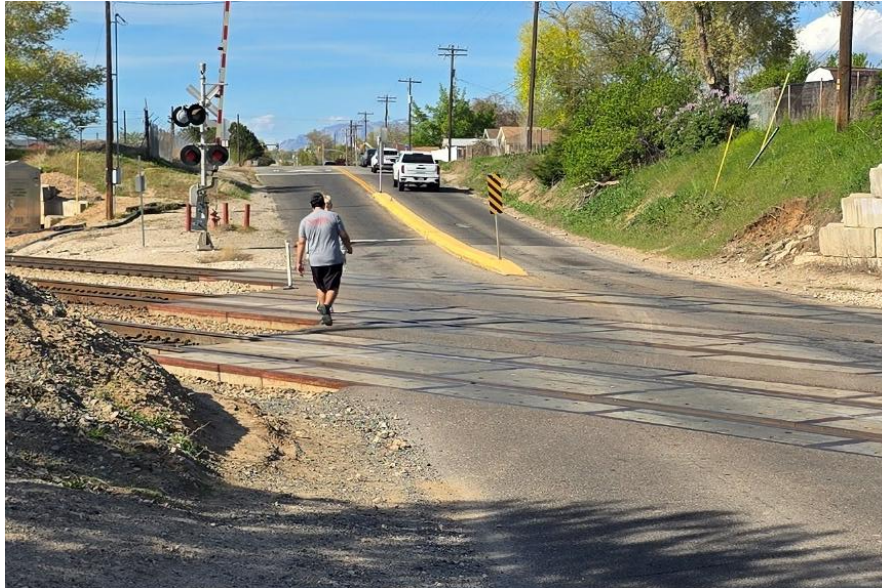
**Issue #3:** Pedestrians and bicyclists continue to cross at-grade despite lack of crossing infrastructure.

- Install pedestrian bridge

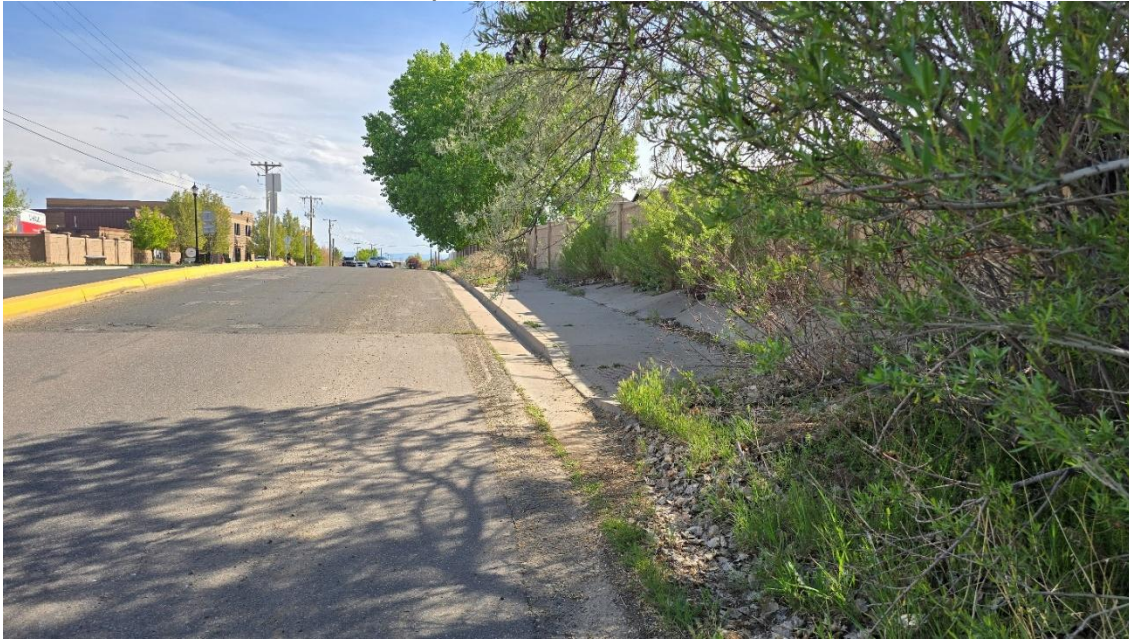
**Issue #5:** Sidewalk on southwest quadrant is overgrown and virtually unusable.

- Trim landscaping and improve sidewalk on southwest quadrant

| ID | Location | Measure | CMF | 20-Year Benefit | 20-Year Cost | Benefit-Cost Ratio (B/C) |
|---|---|---|---|---|---|---|
| S-7 | RR Crossing | Improve sidewalk on southwest quadrant | 0.974 | \$18,000 | \$7,000 | 2.57 |

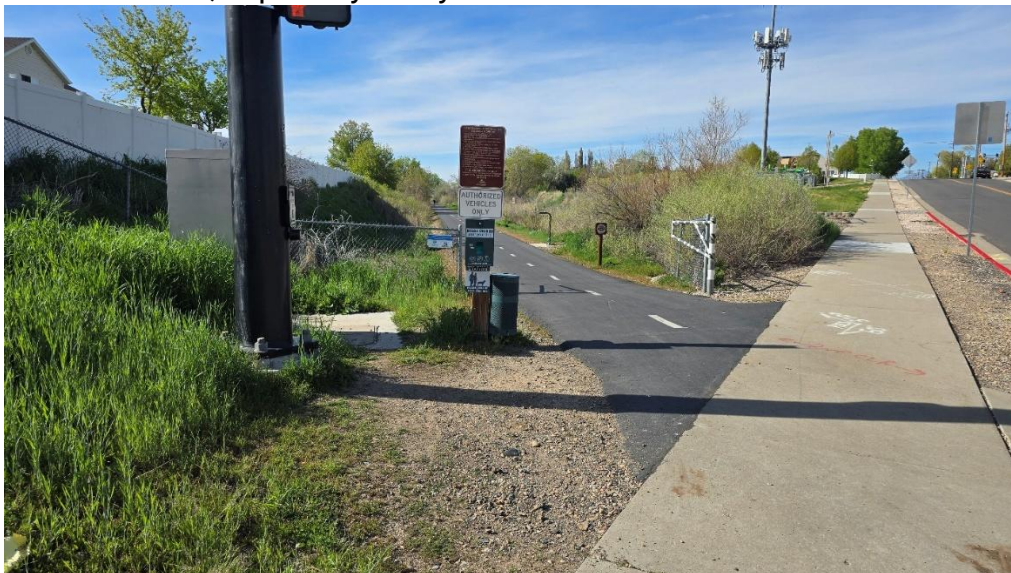
**Issue #1:** Pedestrian push button location on west side does not meet ADA standards and is difficult to reach, especially for cyclists.

- Relocate signs and obstacles
- Pave approach to pedestrian push button

- Relocate pedestrian push button to be ADA and bicycle accessible

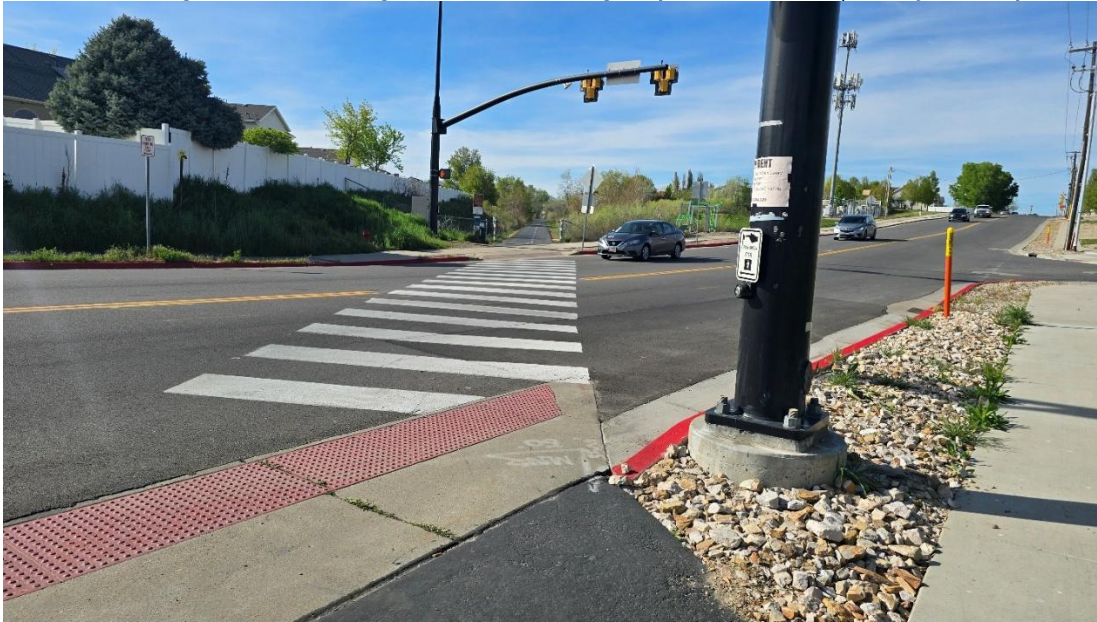
**Issue #3:** Crossing is on the diagonal, increasing exposure time (but cyclists prefer this).

- Realign crossing to be perpendicular & install fencing to direct users
- Raised median through crossing

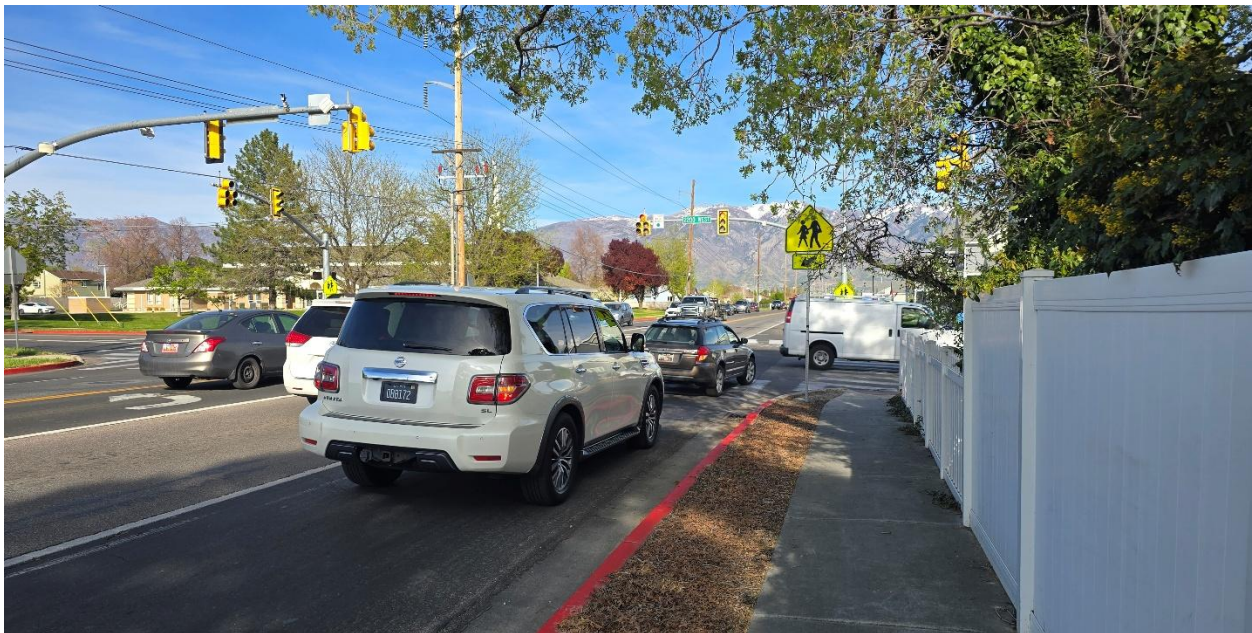
**Issue #2:** Wide shoulders are being used as informal right-turn lanes, creating conflicts with vehicles turning right from the through/right-turn lane.

- Stripe hatch marks in the shoulder; install flex posts

- Install bulb-outs

| ID | Location | Measure | CMF | 20-Year Benefit | 20-Year Cost | Benefit-Cost Ratio (B/C) |
|---|---|---|---|---|---|---|
| S-11 | Gordon Avenue | Stripe hatch marks in the shoulder; install flex posts | 0.920 | \$2,360,000 | \$52,600 | 44.87 |

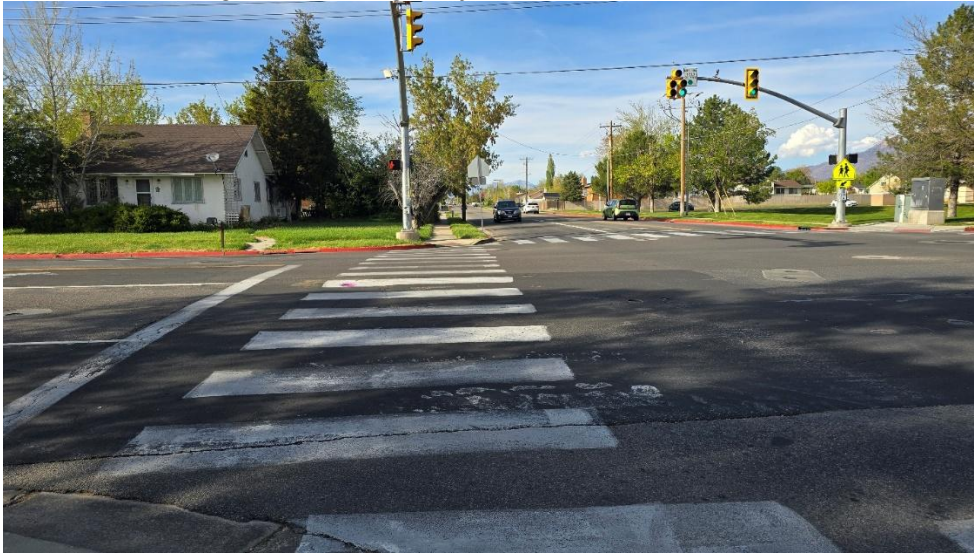
**Issue #3:** School crossing on west leg may not be warranted.

- Evaluate crosswalk striping; restripe as warranted

| ID | Location | Measure | CMF | 20-Year Benefit | 20-Year Cost | Benefit-Cost Ratio (B/C) |
|---|---|---|---|---|---|---|
| S-12 | Gordon Avenue | Evaluate and update as appropriate crosswalk striping | 0.990 | \$295,000 | \$54,100 | 5.45 |
