# ROAD SAFETY AUDIT: 5500 WEST IN HOOPER CITY

5/21/2026

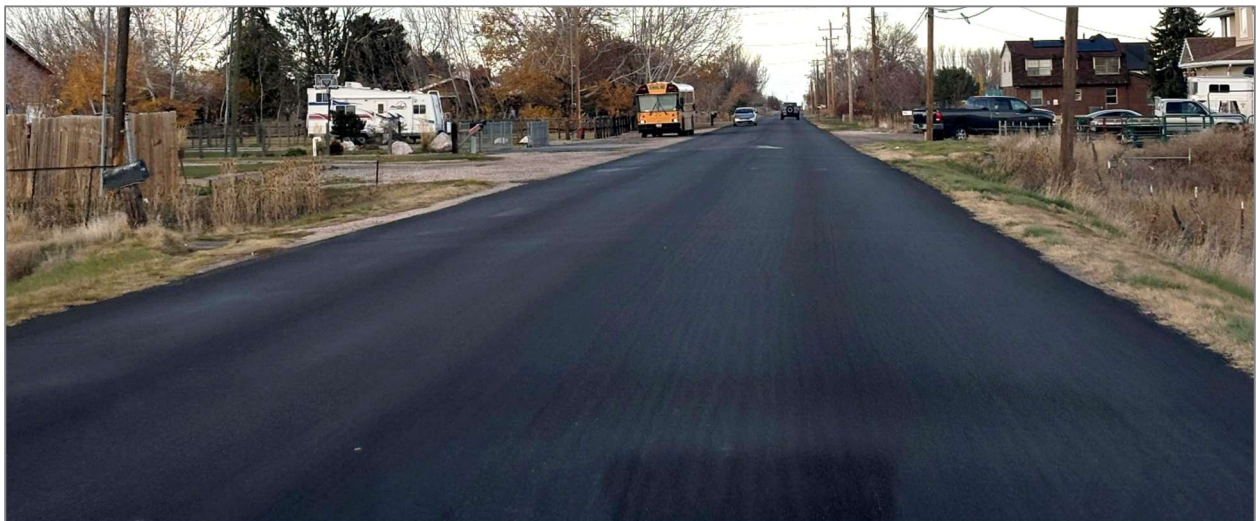
**Issue #2:** There is no shoulder striping along the corridor, and portions of the centerline are faded.

**Short-Term Measure:** Consider edge striping to help differentiate the edge of the roadway and repaint the centerline.

**Long-Term Measure:** Consider center or edge rumble strips.

- **Not to advance – Rumble strips along 5500 West can increase the noise in the community, though sinusoidal rumble strips can result in less noise. Based on the crash history, only one crash has been recorded involving a vehicle drifting into the opposing lane. If additional crashes of this nature are reported, sinusoidal centerline rumble strips should be considered.**

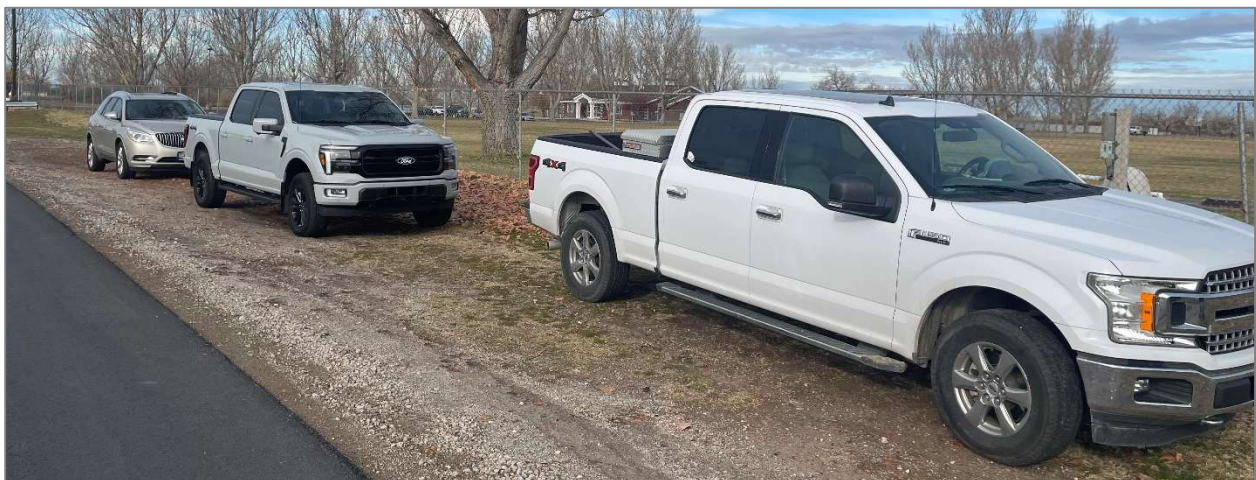
**Issue #1:** Cars parking on the street restrict sight distance. Cars park here to access Hooper North Park, which has limited parking.

**Long-Term Measure:** Update the 5500 West cross section at the park. The cross section can include on-street parking, bulb-outs at 4550 South and 4600 South to prevent vehicles from parking at the intersections, and crosswalks with supportive

treatments across 5500 West, 4550 South, and 4600 South. Speed feedback signs can also be installed near the park.

- **To advance – bulb outs can be created with paint or textured treatments or mountable curbing to allow vehicles with trailers to still be able to make wider turns.**

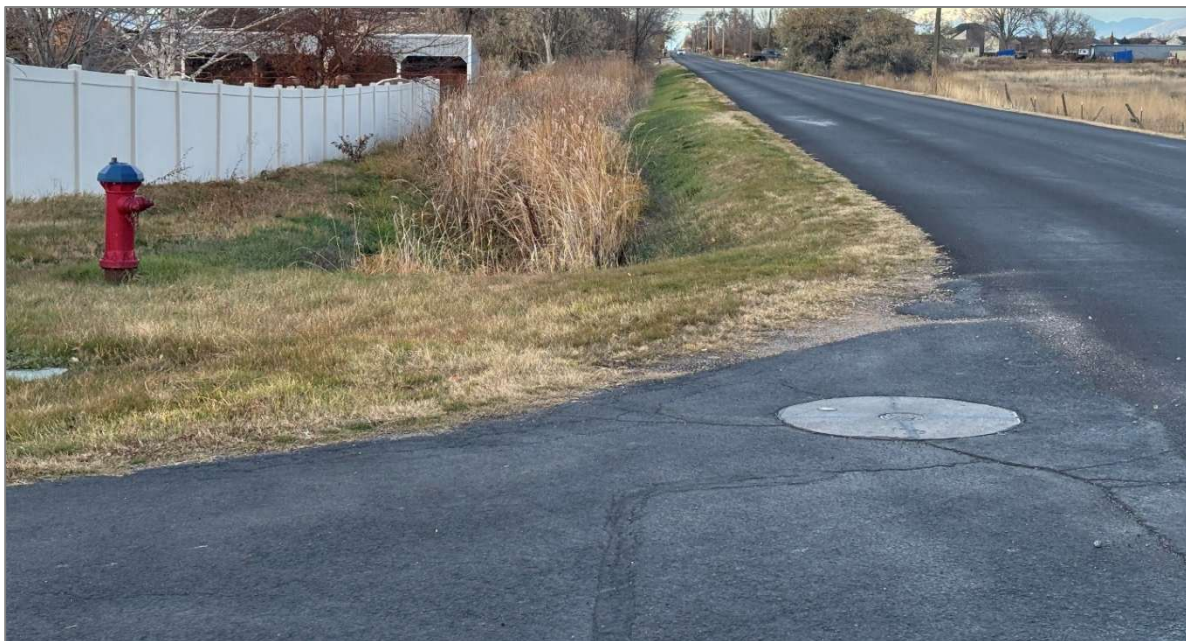
**Issue #1:** There is a slough near the intersection in the clear zone. In addition, it limits construction. As a result, there are no shoulders on this section of the corridor.

**Short-Term Measure:** Consider edge striping to help differentiate the edge of the roadway.

**Long-Term Measure:** Install a guardrail on the east side of the road to prevent vehicles from entering the slough.

- **Not to advance – Wide farm equipment uses this roadway and could hit and damage a guardrail.**

**Long-Term Measure:** Install piped irrigation at this location and flatten the side slope.

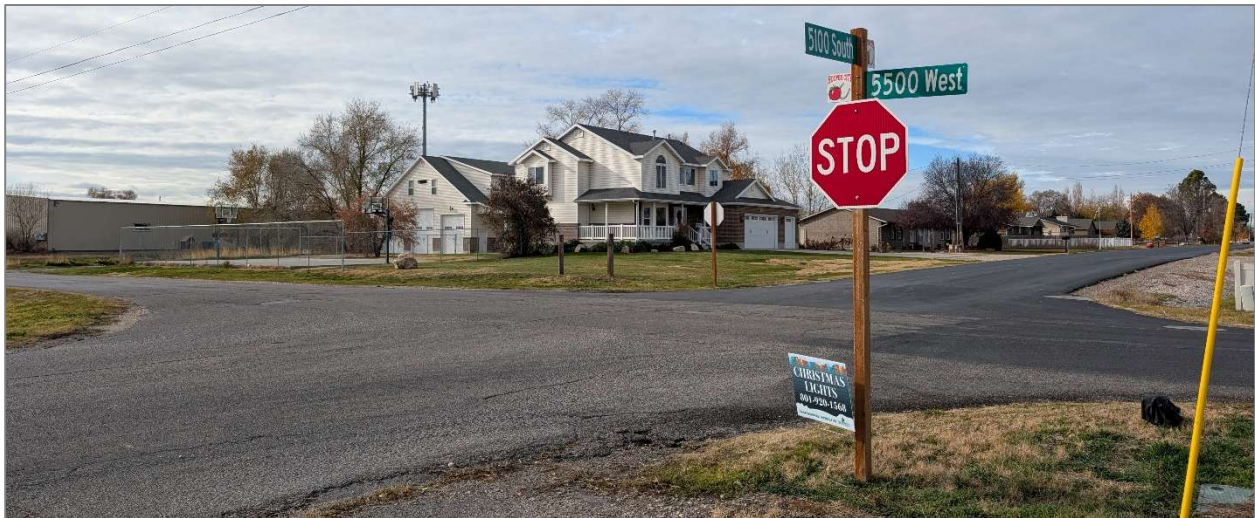
**Issue #2:** Vehicles either ignore or roll through the east and westbound stop signs.

**Short-Term Measure:** Install stop bars on side streets to make intersections more visible.

**Short-Term Measure:** Separate the stop sign from street signs, as well as implementing other multiple low-cost countermeasures such as double stop signs and stop ahead signs, and LED flashers.

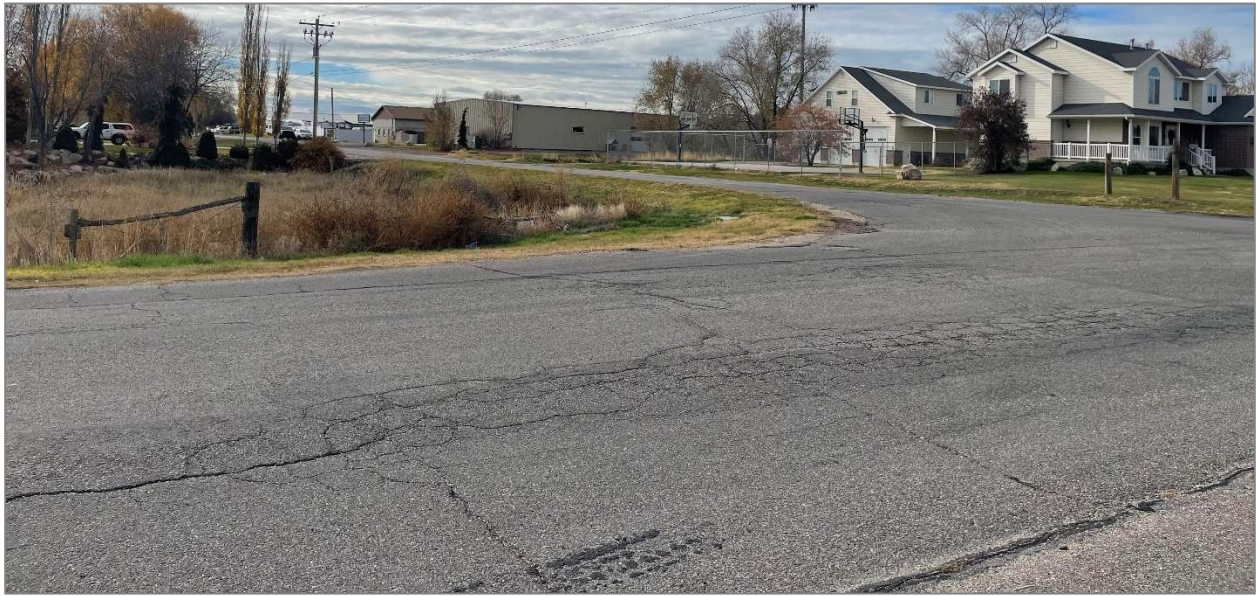
**Issue #3:** The trail on the east side of this intersection ends with no connection to the shared-use path south of 5300 South.

**Long-Term Measure:** Extend active transportation network south to connect to existing shared-use path on the west side of 5500 West.

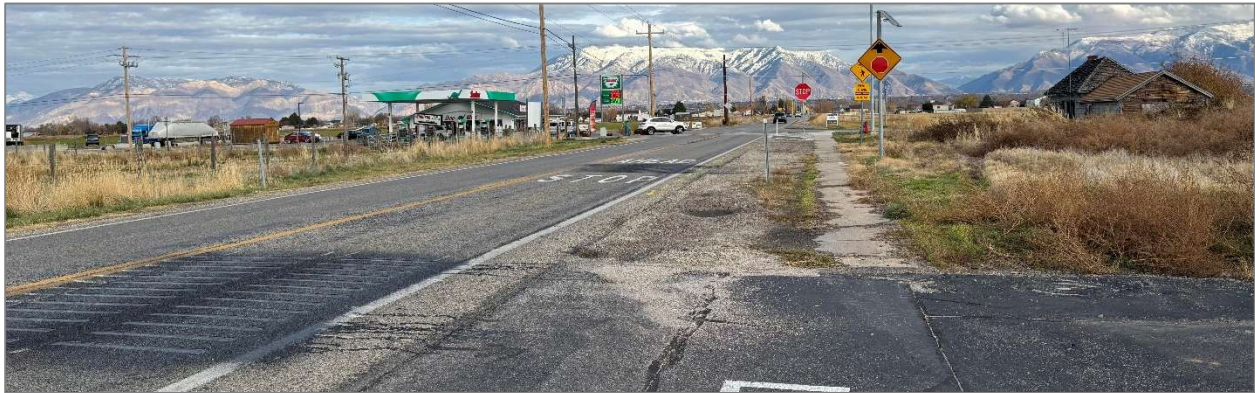
**Issue #1:** Vehicles on 5500 South (SR-97) are approaching the intersection too fast as they have not adjusted to the new traffic control. The posted speed limit on 5500 South (SR-97) is 50 mph east of 5500 West and 40 mph west of 5500 West.

**Short-Term Measure:** Implement additional low-cost countermeasures such as double stop signs and stop ahead signs, and LED flashers.

**Medium-Term Measure:** Install a special emphasis crosswalk for the shared-use path crossing on the west side of the intersection, increasing pedestrian visibility.

**Long-Term Measure:** Move the existing or add additional transverse rumble strips on 5500 South (SR-97) further from the intersection so drivers have more warning to reduce their speed approaching the stop signs.

**Long-Term Measure:** Implement a roundabout at this location. An Intersection Control Evaluation (ICE) study completed by UDOT in 2020 determined that a single lane roundabout was determined to have the highest life-cycle benefit-cost.

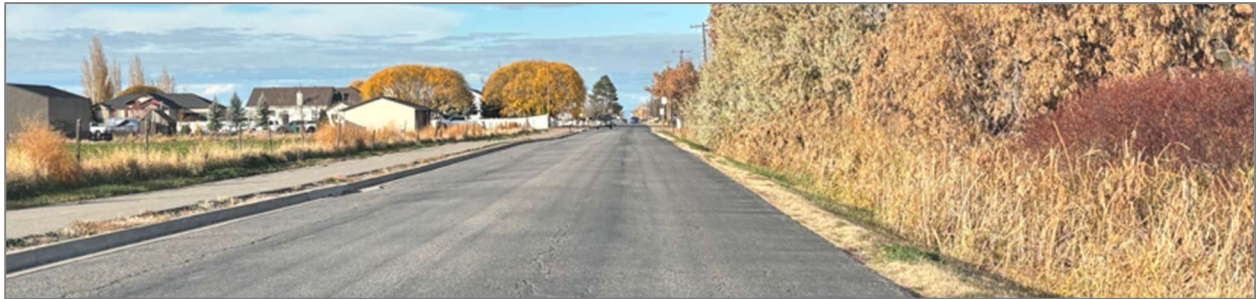
**Issue #1:** There is a steep slough on the east side of the roadway in the clear zone. There are currently plans to fill the slough on the east side of the road and widen the road to the east.

**Short-Term Measure:** Consider edge striping to help differentiate the edge of the roadway.

**Long-Term Measure:** Install a guardrail on the east side of the road to prevent vehicles from entering the slough.

- **Not to advance – Wide farm equipment uses this roadway and could hit and damage a guardrail.**

**Long-Term Measure:** Continue with plans to install piped irrigation at this location. Currently, plans are for construction to begin in 2027.

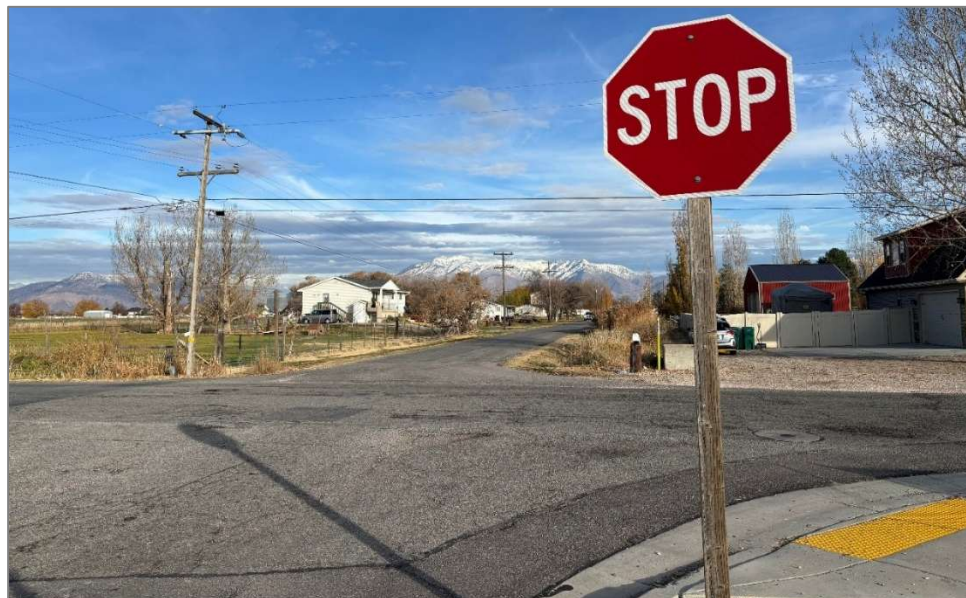
**Issue #2:** Intersection is unexpected.

**Short-Term Measure:** Implement low-cost countermeasures such as double stop signs and stop ahead signs, and LED flashers.

**Short-Term Measure:** Install stop bars on the east and westbound approaches.

**Medium-Term Measure:** Consider lighting at intersection.
