# ROAD SAFETY AUDIT: 10600 SOUTH IN WHITE CITY

8/24/2026

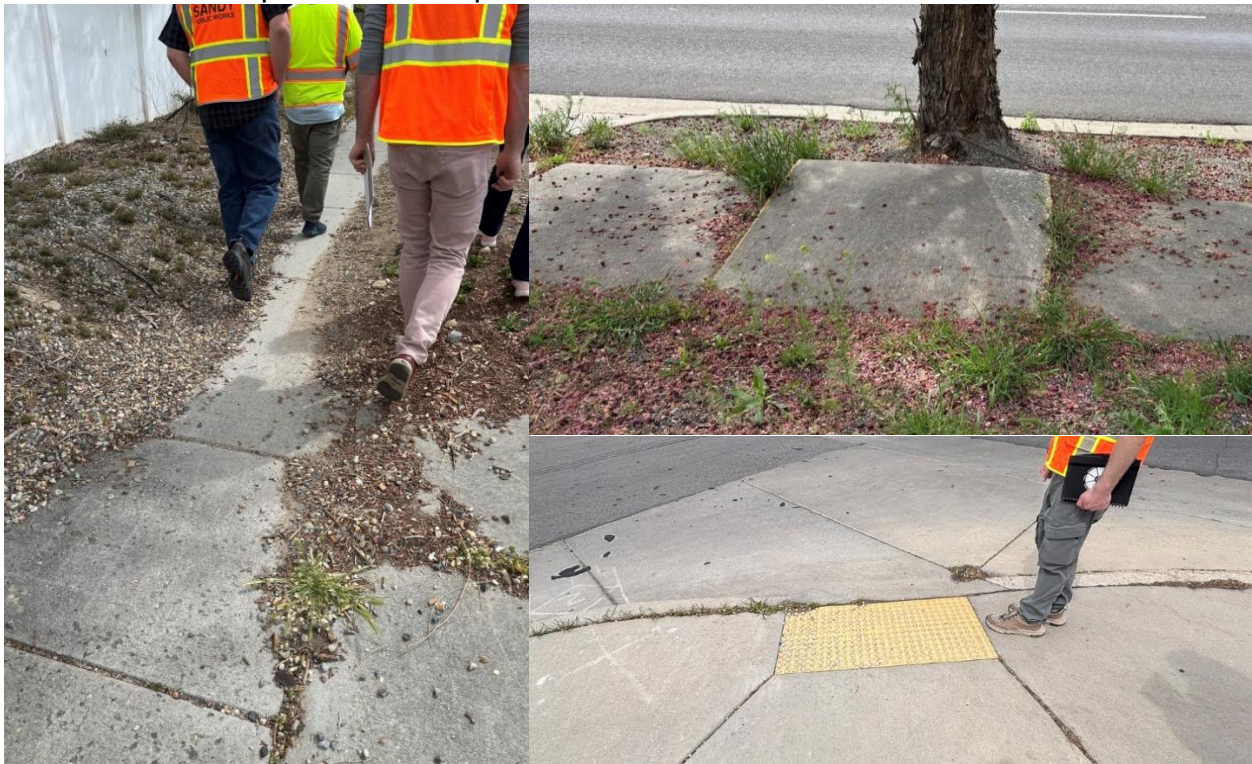
**Issue #3:** Narrow and displaced sidewalks and lack of shoulders reduce pedestrian comfort. ADA ramps are not compliant.

- Clean sidewalks and clear overgrowth to regain full width
- Consider restriping corridor to narrow lanes and create a 1' shoulder
- Stripe edge lines

- Repair crumbling and displaced sidewalk sections
- Update pedestrian ramps to be ADA compliant

- Convert to a 3-lane cross-section or widen the roadway to allow for wider sidewalks and plant strips, shoulders, and possibly bike lanes

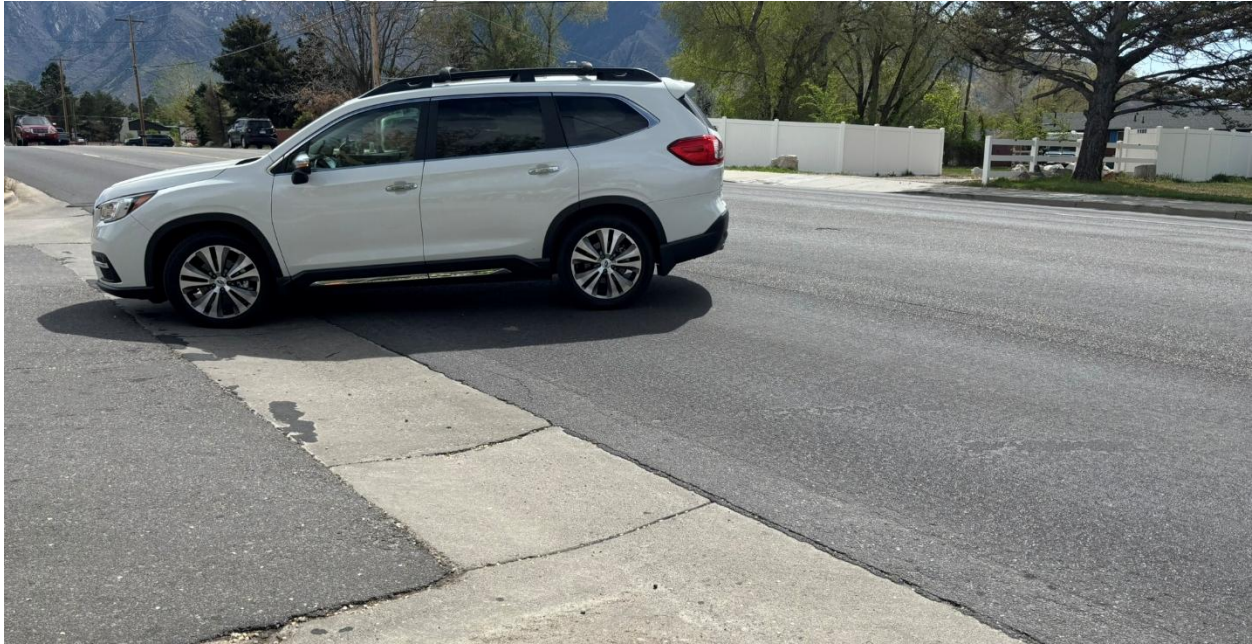
**Issue #4:** Drainage and gutter profiles create uneven roadway conditions.

- Regrade road and drainage channels to smooth vertical deflections

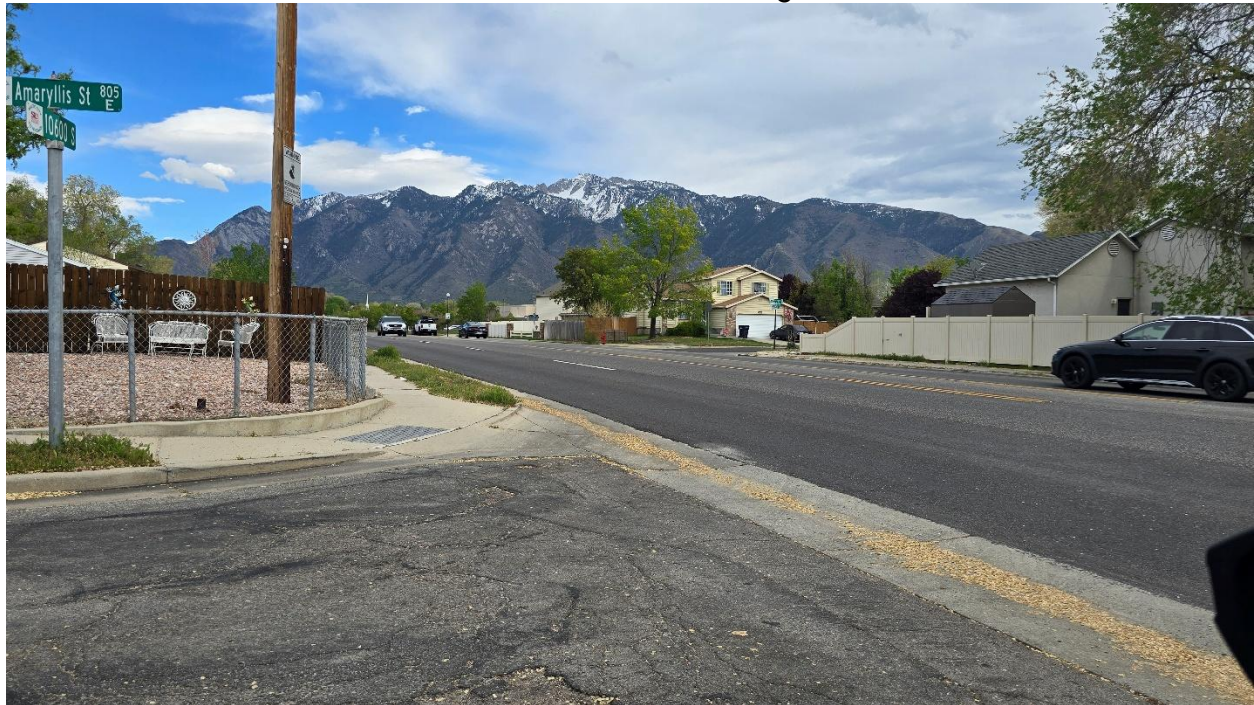
**Issue #6:** Vertical curvature and obstacles constrain sight distances.

- Clean sidewalks and clear overgrowth to regain full width

- Update local ordinances as needed to ensure obstacles are not built or placed in sight lines

- Convert to a 3-lane cross-section or widen the roadway to allow for wider sidewalks and plant strips, shoulders, and possibly bike lanes

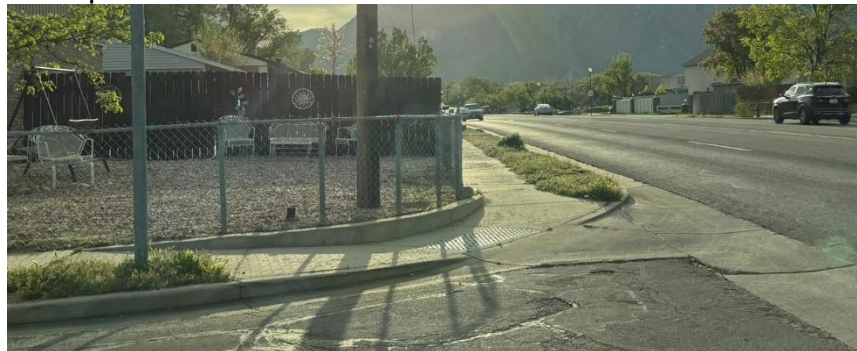
**Issue #1:** ADA Ramps do not meet standards.

- Update pedestrian ramps to be ADA compliant
- Repair crumbling and displaced sidewalk sections

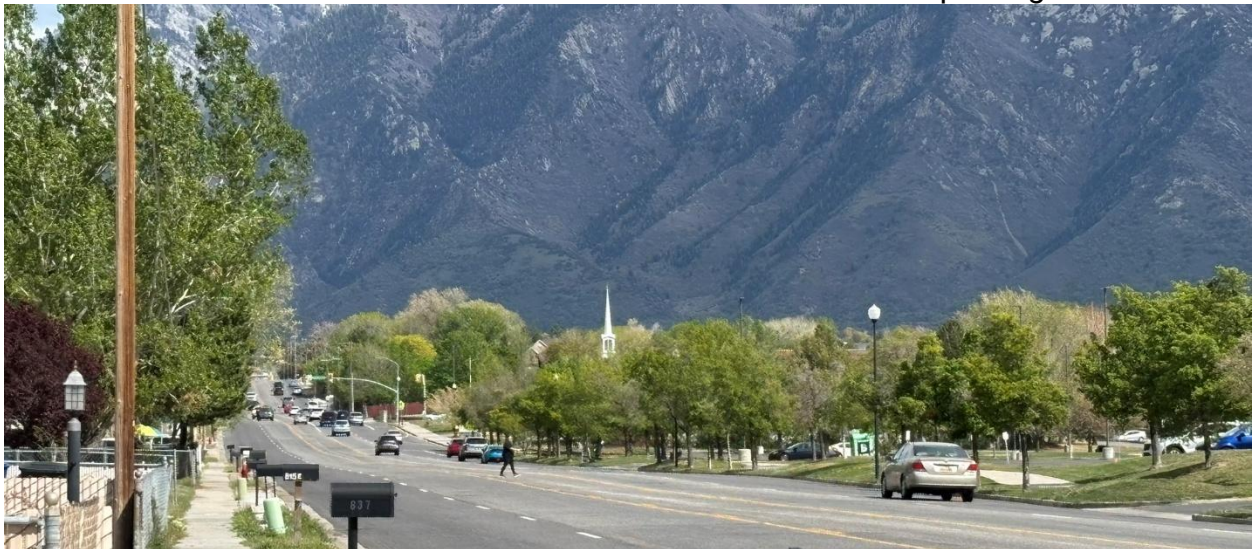
**Issue #1:** Pedestrians cross midblock to access recreation center parking.

- Evaluate location for a pedestrian crosswalk, including latent demand

- Install crosswalk with supportive treatments (RRFB, pedestrian refuge island, lighting, pedestrian fencing in other locations)
- Consolidate access points for Dimple Dell Recreation Center and proximate church

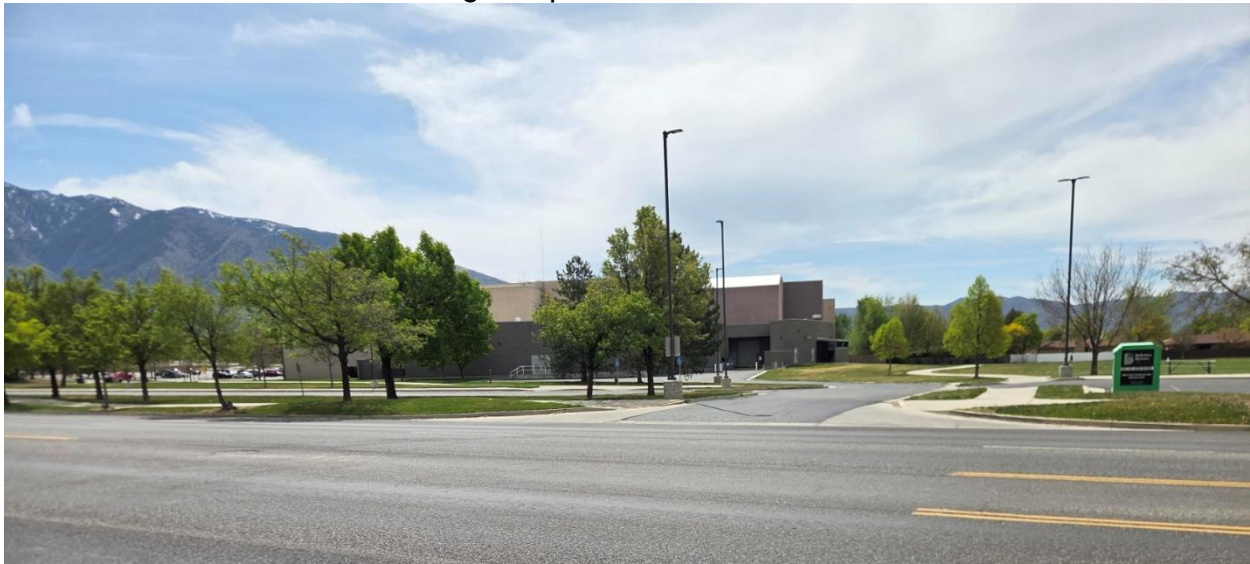
**Issue #2:** Lack of formal crossing at a potential desire line.

- Evaluate location for a pedestrian crosswalk, including latent demand
- Evaluate access and circulation at the Dimple Dell Recreation Center

- Install crosswalk with supportive treatments (RRFB, pedestrian refuge island, lighting, pedestrian fencing in other locations)
- Consolidate access points for Dimple Dell Recreation Center and proximate church

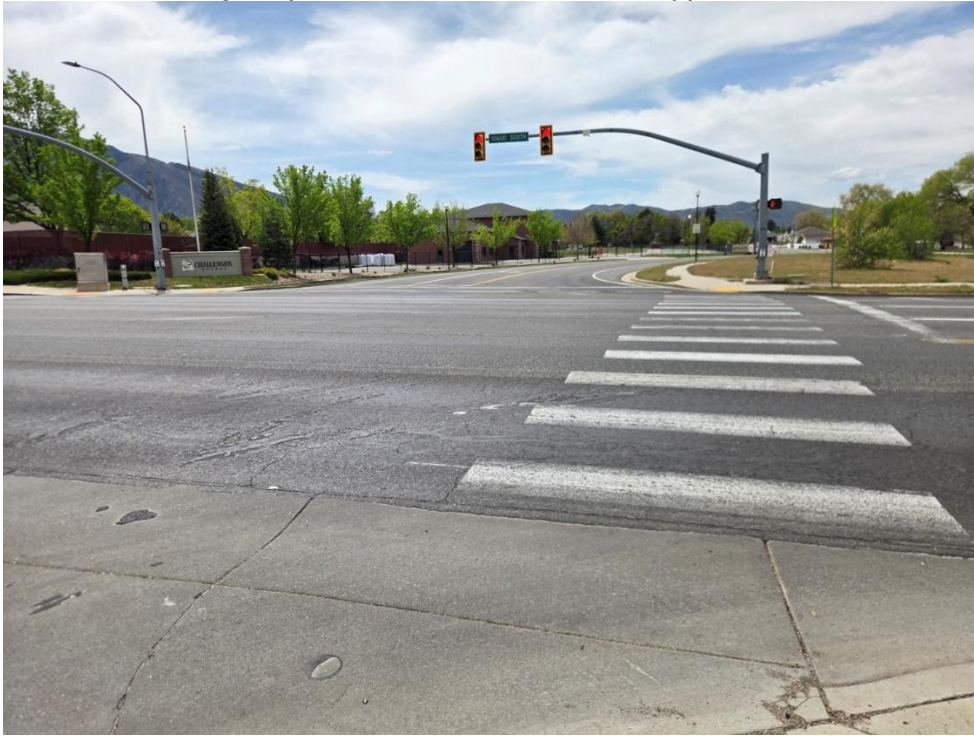
**Issue #1:** School crossing may not be warranted for the type of users.

- Evaluate existing school crosswalk and potentially restripe as standard crosswalk

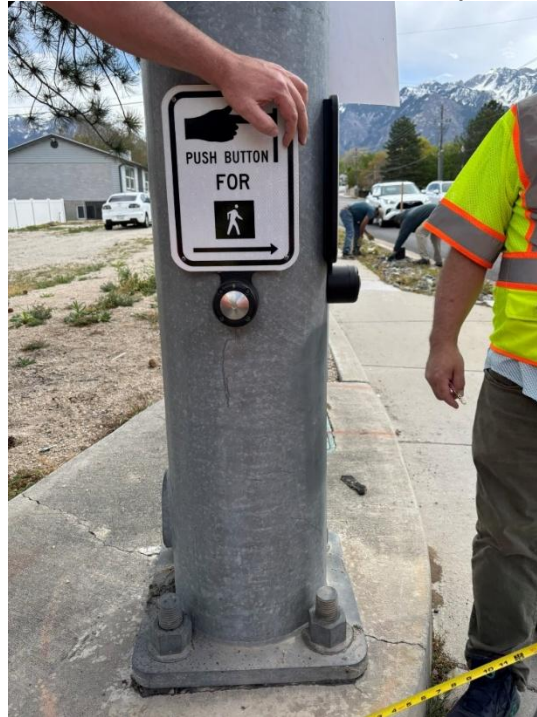
**Issue #6:** Pedestrian activation buttons are not ADA compliant.

- Relocate pedestrian activation buttons to meet ADA requirements

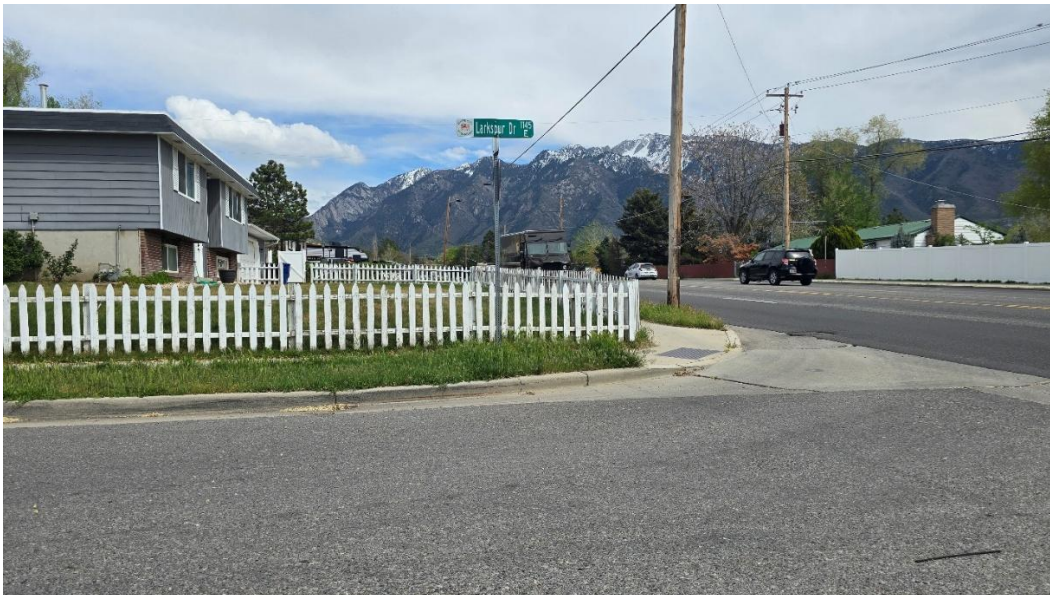
**Issue #1:** Limited sight distance due to fencing, obstacles, and lack of shoulder. Vehicles must pull into forward to see traffic.

- Move fence out of sight lines

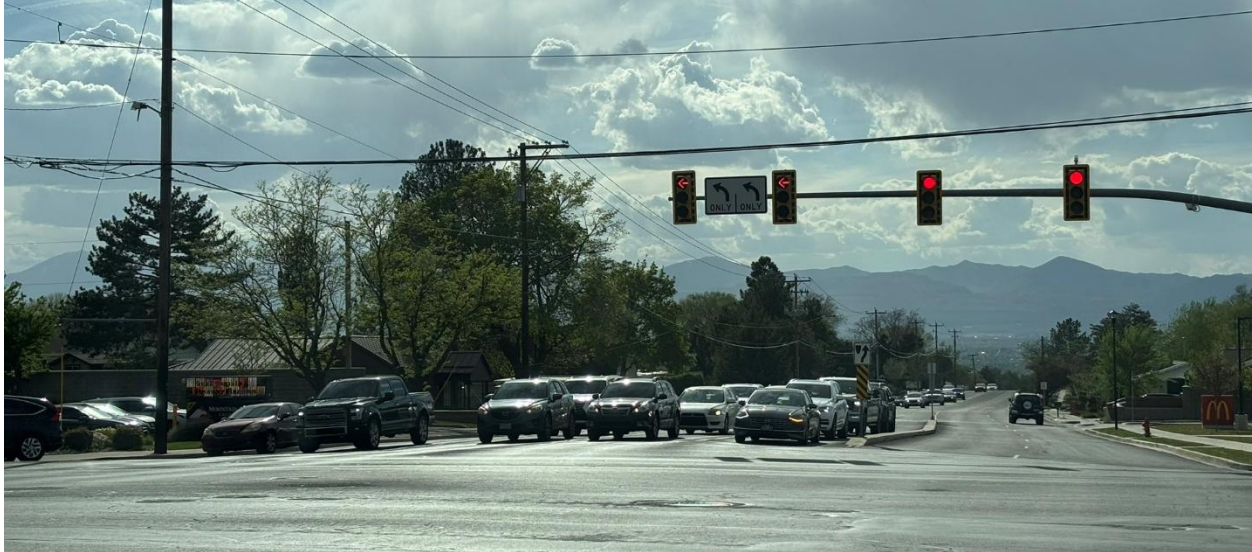
**Issue #1:** Queue spillback from 1300 East can block intersection in peak periods.

- Extend raised median past Primrose Drive to convert McDonald's & Primrose Drive into right-in/right-out access

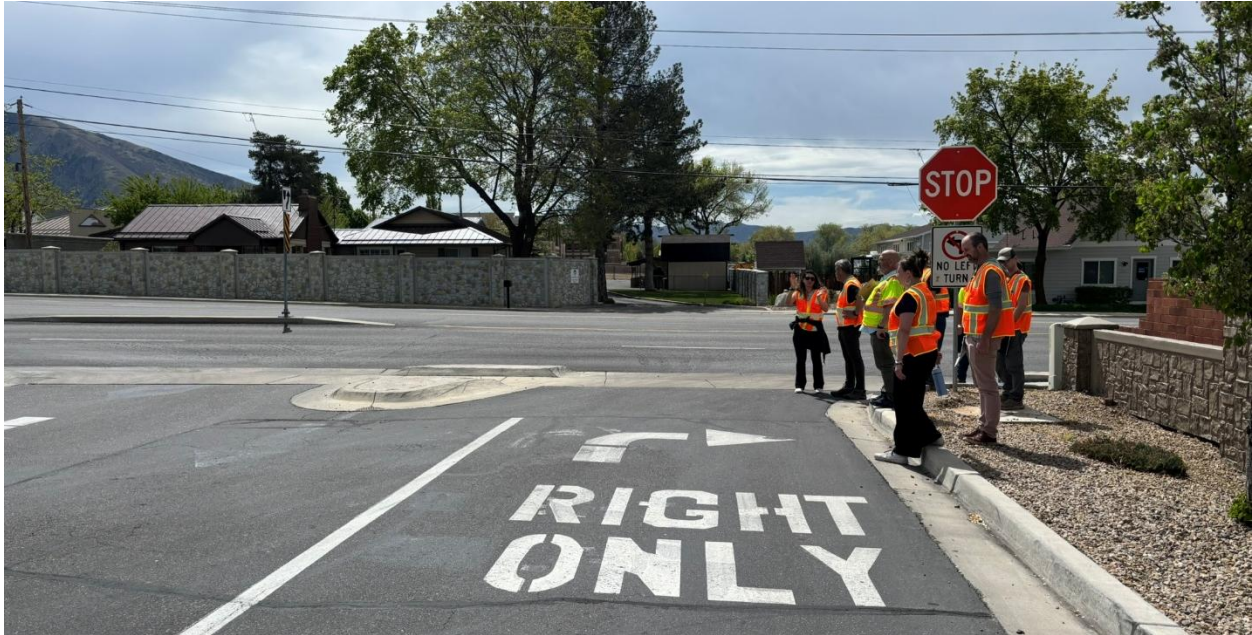
**Issue #1:** Median was shortened allowing left turns in and out.

- Extend raised median past Primrose Drive to convert McDonald's & Primrose Drive into right-in/right-out access

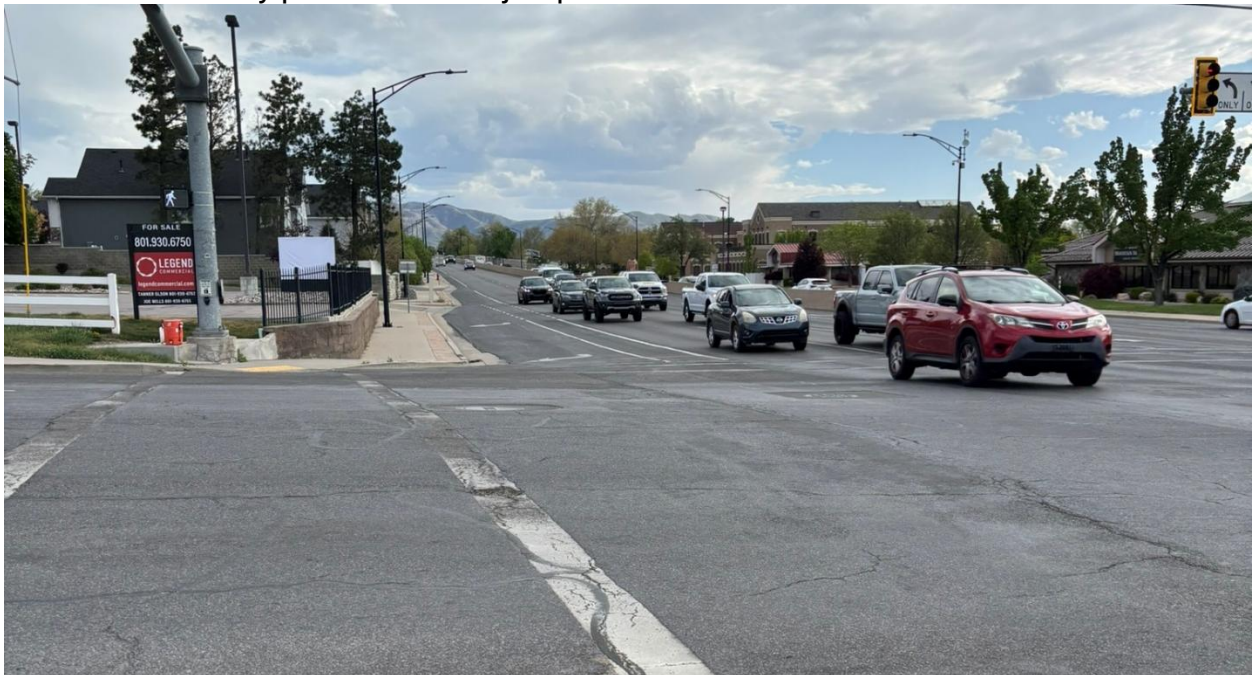
**Issue #1:** Roadway profile creates “jump” for northbound vehicles.

- Systemic improvements at signals on high-speed corridors (wide edge striping, speed limit and signal ahead signs, speed feedback sign, pavement speed limit marking)

- Regrade intersection to eliminate high point
