# ROAD SAFETY AUDIT: 2200 WEST IN LAYTON (GORDON AVE TO ANTELOPE DR)

8/24/2026

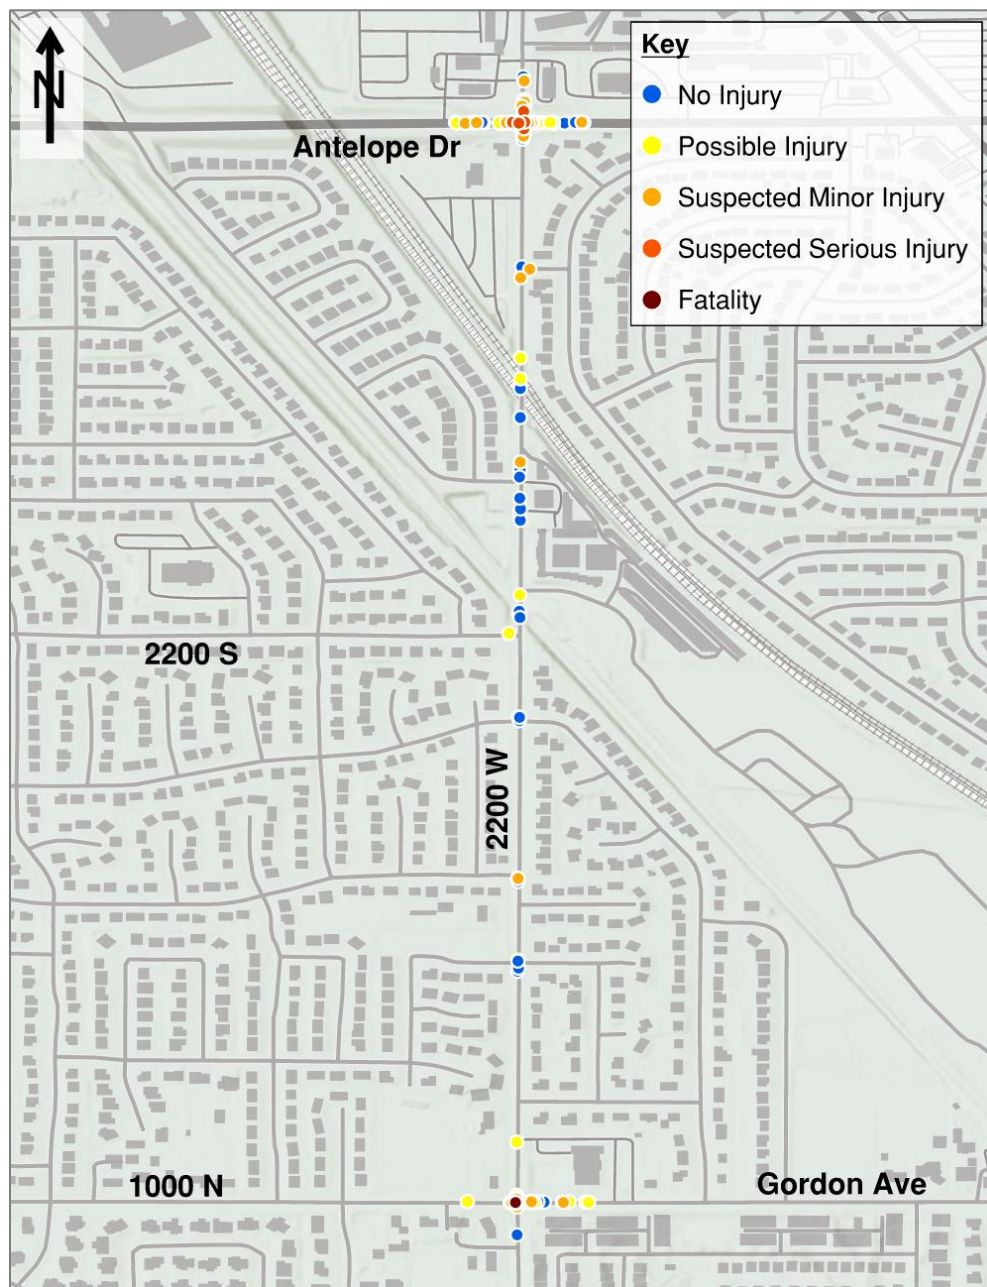
Figure 6: Crash Summary

Crash data was obtained from the UDOT Traffic and Safety Division. Crash data may be protected under 23 USC 407. Data from the most recent five full years (January 2020 to December 2024) was used. Crashes reported in 2025 and 2026 were also reviewed, but they may not be fully verified. Crashes are summarized in [Table 2](#) shown in [Figure 6](#).

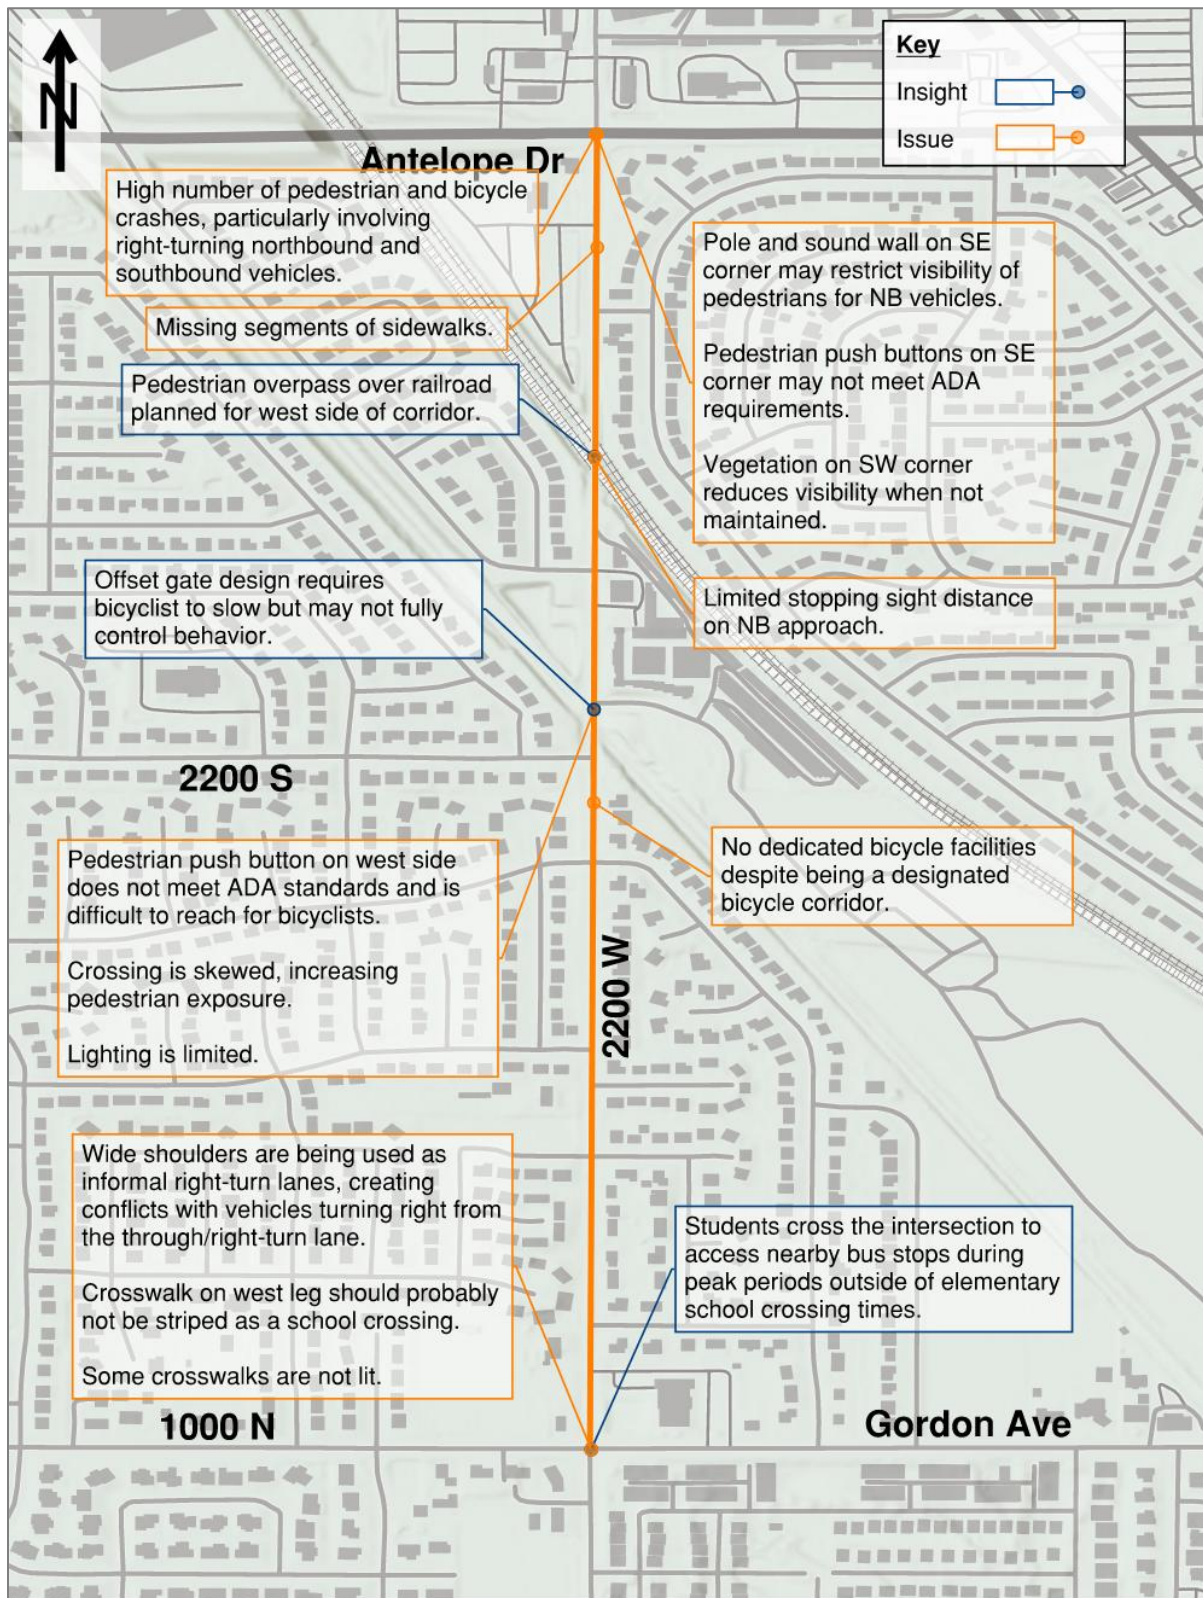
Figure 7: Insights and Issues Summary

A summary map of all location-specific insights and issues is shown in **Figure 7**. Insights are not necessarily safety concerns, but observations or background information that inform recommended safety measures. Issues are safety concerns which the suggested measures intend to address.

**Issue #1:** Large segments of sidewalk are missing north of the rail crossing.

**Issue #6:** Long queues and observed cycle failures for turning movements during peak periods (particularly eastbound left turn in AM, northbound left turn in PM).

**Issue #8:** There are no sidewalks on the south leg, but pedestrian activity is evidenced by worn footpaths on both sides of the road.

- Complete missing sections of sidewalk
